Manhole Inspection Summary

Manhole # S19W__004MH

Location Address: **2324 herkimer st**

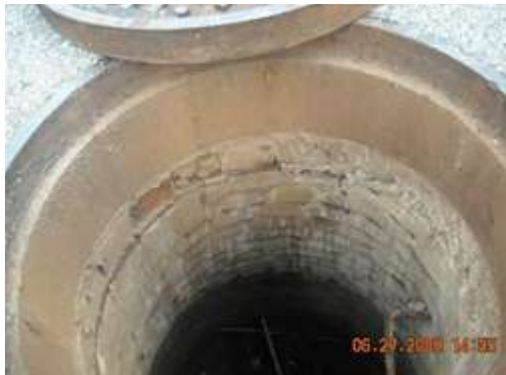
Misc

Subject To Ponding: **Sheeting**

inflow evidence from sheeting

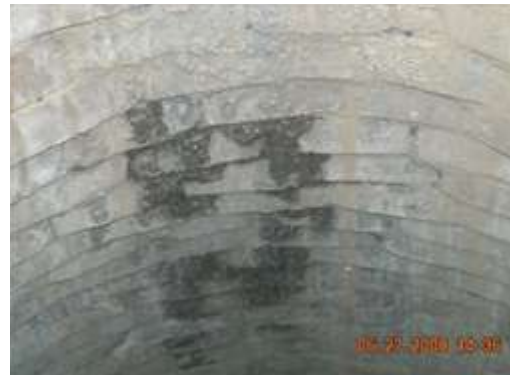
Defect 3

Infiltration: ☐ None ☐ Joint ☐ Cracks ☐ Mortar ☐ Roots ☒ Wall

infiltration @ corbel wall

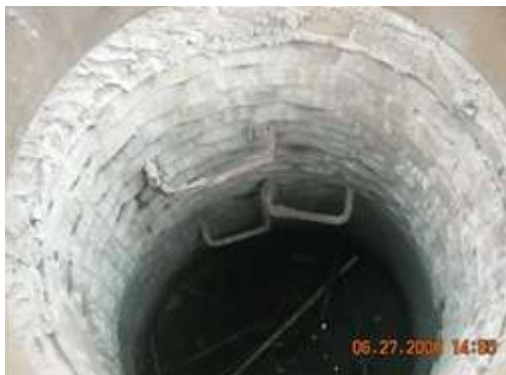
Defect 2

Count: **3** Missing: **0** ☒ Corroded

corroded steps

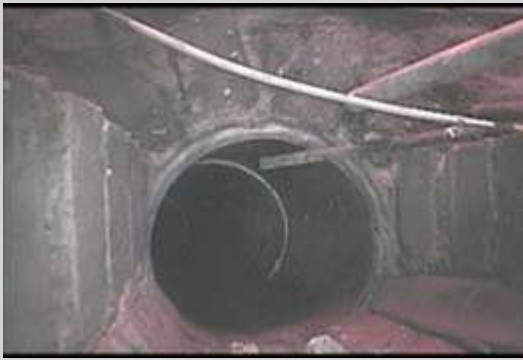
12 O'Clock Outflow

8 in. Circular Gravity Sewer
Pipe Out @ 12 O'Clock

Pipe Height: **8.4** (in.) Rod and Bar (Angled)
Pipe Material: **Clay** ☐ Pipe Lined
Invert Depth: **7.24** (ft.) Flow Characteristics: **None**
Deposits: ☐ None ☐ Mud ☐ Sludge ☒ **Debris** ☐ Grease
Silt Depth: **1** (in.) Deposits Extent: **Light**
Infiltration: **None** Pipe Seal Cond: **Sound**

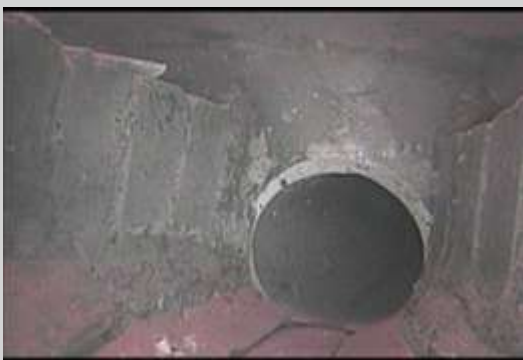
9 O'Clock Inflow

6 in. Circular Gravity Sewer
Pipe In @ 9 O'Clock

Pipe Height: **6** (in.) Rod and Bar (Angled)
Pipe Material: **Clay** ☐ Pipe Lined
Invert Depth: **7.15** (ft.) Flow Characteristics: **None**
Deposits: ☒ **None** ☐ Mud ☐ Sludge ☐ Debris ☐ Grease
Silt Depth: **0** (in.) Deposits Extent:
Infiltration: **None** Pipe Seal Cond: **Sound**
